Miscellaneous Paper SL-94-1  
April 1994

## Efflorescence Study, Fort Leonard Wood, Missouri

by Tony B. Husbands

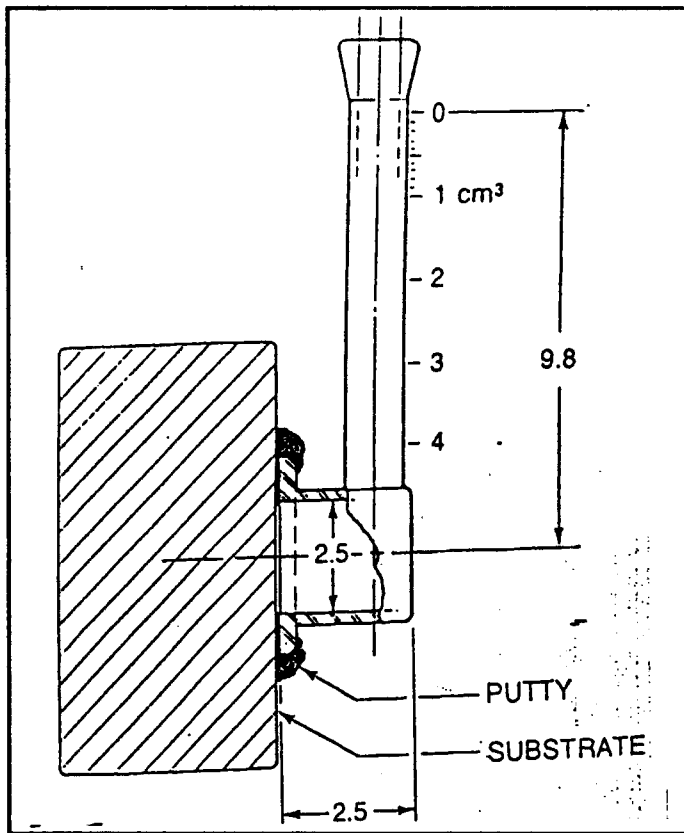
Two test methods were selected for measuring water penetration the RILEM test and a method developed by the Construction Technology Laboratory (CTL). The RILEM test consists of the use of a graduated plastic cylinder that is mounted to a wall or test specimen by means of a putty. The apparatus is filled with water and the quantity of water entering the material during a specified period of time is read directly from the graduated tube. A RILEM tube with dimensions is shown in Figure 5. CTL's test apparatus consists of a 2-in.-diam chamber, which is attached to a wall. Two anchors were placed in a bed joint and two clamps were attached to the wall to firmly support the chamber against the wall. Putty was placed in front of a rubber gasket that sets around the chamber (Figure 6). Water was then pumped to the chamber until the chamber was filled as indicated by an overflow valve. Water was then forced into the wall under pressures ranging from 5 to 15 ps; 5 psi was selected for these tests. The amount of water penetration was then measured by a flow meter. A test in progress is shown in Figure 7.

Figure 5. RILEM tube
